Using Infrared Thermography to Determine the Presence & Correct Placement of Grouted Cells in Single-Width Concrete Masonry Unit (CMU) Walls

Gregory R. Stockton, President
Stockton Infrared Thermographic Services, Inc.
Randleman, NC

Lee R. Allen, President
Allen Applied Infrared Technology, Inc.
Coward, SC

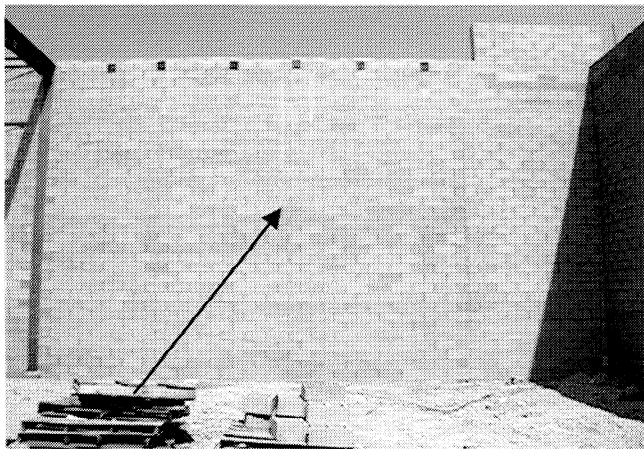
Figures 1 & 2) Photograph and Thermograph of CMU Wall with Excess Grouting

Due to their real world experiences at job sites, the perception among engineers and designers is that some 'errors' are going to take place during the construction. This leads to a tendency to 'over-design' the building somewhat to compensate for inevitable faults, which adds to construction costs and complicates the job. We find many problems, but they are not usually due to fraud. Instead, a lack of skilled supervision on the wall is the reason for most faulty CMU construction. A masonry contractor may seek to take advantage of the fact that since there is virtually no way and/or no will to see **inside** his work, he can save the expense of putting a highly skilled supervisor on the job. His past experiences tell him to concentrate on what 'shows'. If the grouting and reinforcement of the walls are of great concern, the GC will lay out the building for his masons. We often find quite a bit of wasted grouting in 'over-poured' walls. This is due to a long perceived notion is that too much [concrete] is always better. However, owners concerned about heating and cooling costs do not want excess grouting in the walls, since it displaces the amount of insulation that can be installed. See figures 1 and 2.

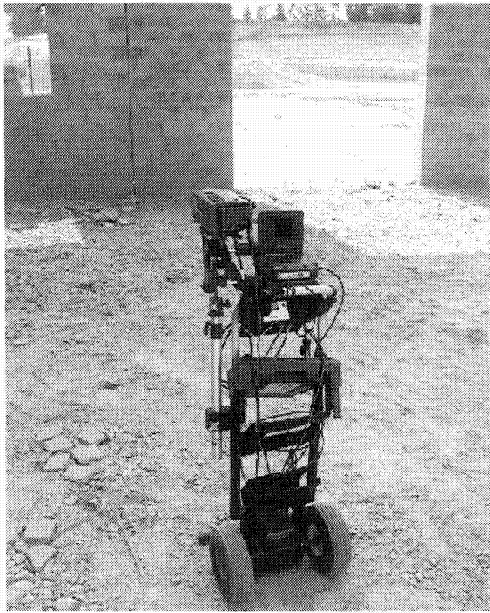
Figure 12) Photograph of a cart-mounted 390 ThermaCAM™, with continuous recording system

We began using an Inframetrics 390 ThermaCAM™ cart-mounted system (see figure 12), recording continuous Hi8mm videotape in 1998. We are currently using a digital visual camera (see figure 13) for the visuals. When we survey large and/or complicated buildings, we record audio (voice) information onto the video, calling out the column lines or other information. Since it does not have the pixels that the Mitsubishis have, we are using a 32 degree wide-angle lens, which allows us to get closer to the wall (to get the pixels), while maintaining the column line-to-column line technique. The big advantage to the ThermaCAM™ is that it is small, lightweight and we can save 12-bit images with the on-board PCMCIA flash card. This allows us to use TherMonitor™ Pro software to recall the images in order and adjust them to our liking. We then cut and paste them into our custom PowerPoint™ templates. Photo-quality prints of individual report pages are then produced to make the report. Since they are .ppt files, we can project them on screen during the report presentations.
