Methodologies for Finding, Analyzing and Prioritizing Moisture Problems in Roofing Materials Using Infrared Thermal Imaging

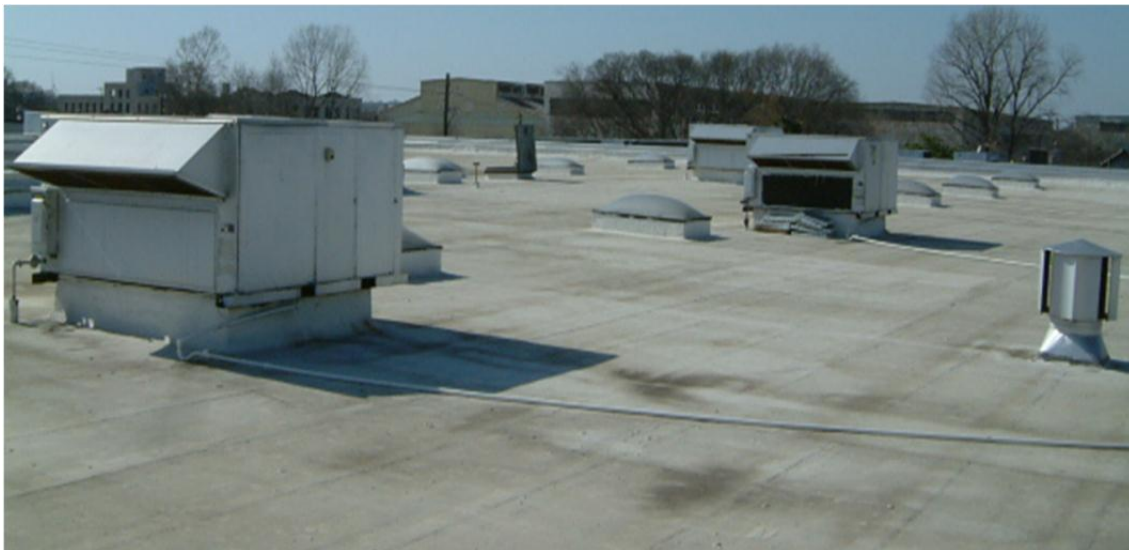
Figure 1) – Typical low-sloped insulated roof

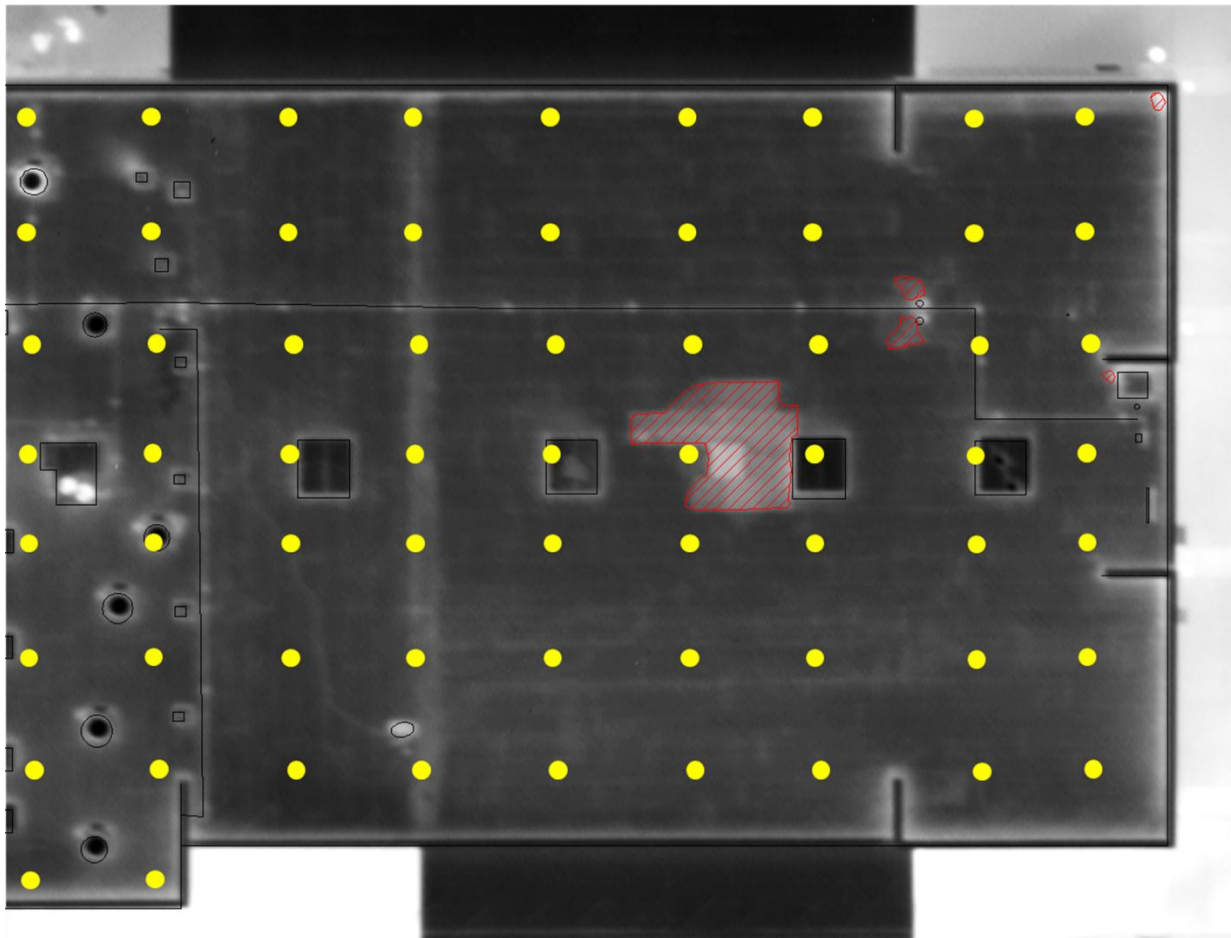
Figure 2) – Infrared thermal image with CAD overlay of wet areas found with infrared testing of a 5000 SF roof section with 80SF of wet insulation and zero wet areas found in 65 readings (yellow marks) using a 10'x10' grid pattern

Both nuclear gauges and capacitance meters are used to take spot readings on either a 20'x20' or 10'x10' or 5'x5' grid on the roof. These measurements are used to extrapolate where the water is from the readings obtained from the gauge. Notwithstanding false or inaccurate readings, the sample of the roof is tiny given the amount of readings and associated labor. **Meter surveys only work to prove that a roof is so widespread wet that they are beyond repair. They are not used to find and delineate areas that need repair.** Meter surveys are primarily used on roof types that do not gain or lose solar energy well or for whatever reason do not lend themselves to infrared.

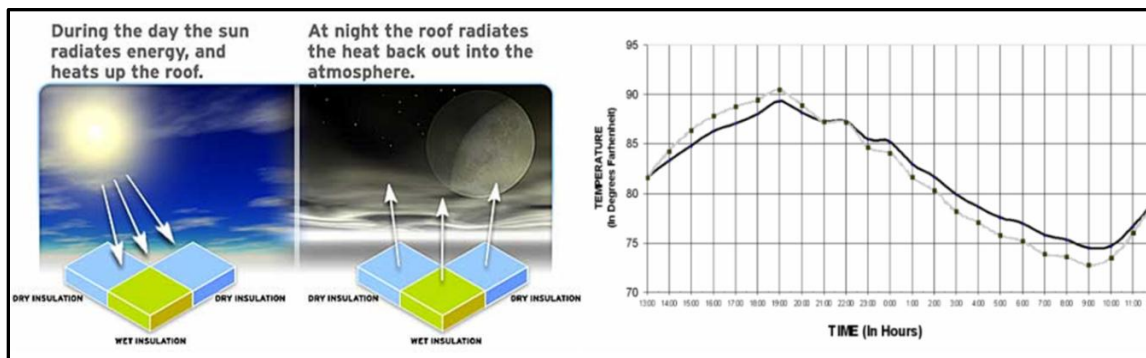
Figure 3) – Diagrams of how heat absorbs into a roof and dissipates from the roof over the diurnal cycle

During the day, the sun radiates energy onto the roof and into the roof substrate, and then at night, the roof radiates this heat back into outer space. This is radiational cooling. Areas of the roof that are of a higher mass (wet) retain this heat longer than that of the lower mass (dry) areas. Infrared imagers can detect this heat and “see” the warmer, higher mass areas, during the “window” of uneven heat dissipation.

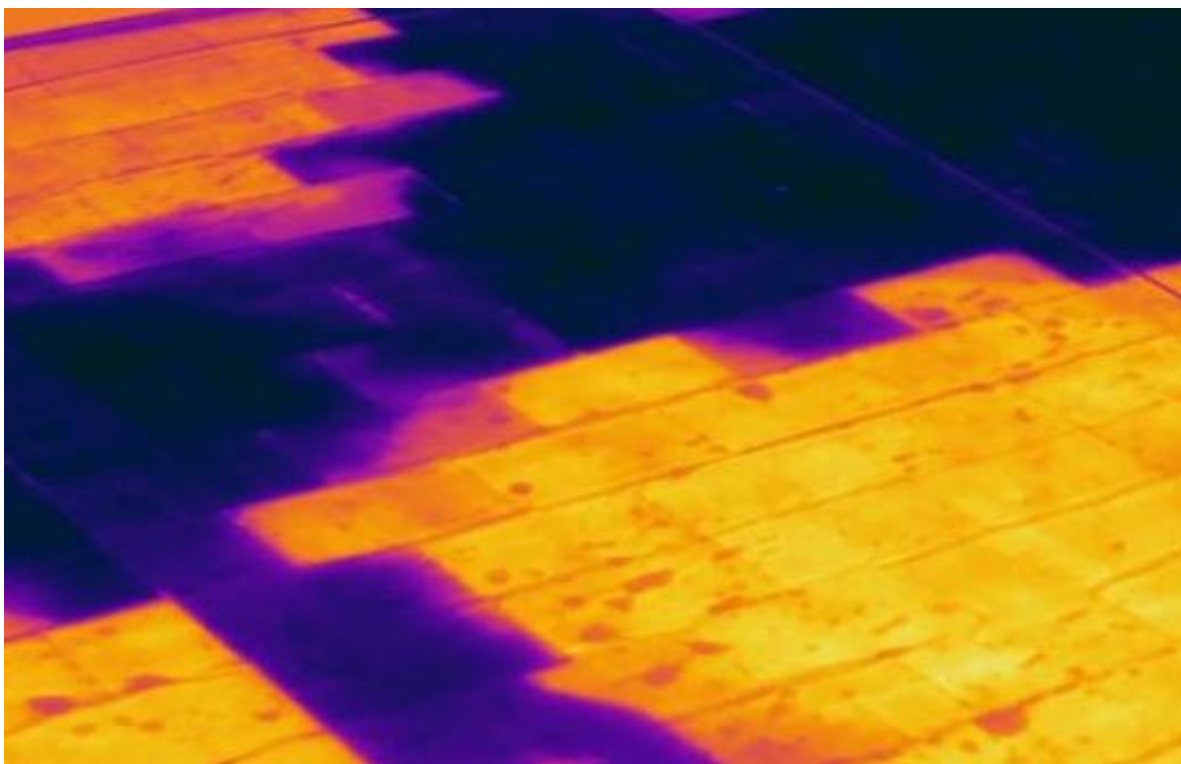
Figure 4) – Thermal image of a flat insulated roof showing clear delineation of wet insulation below the membrane as warmer, lighter-colored areas
(Courtesy of Wayne Swirnow, InfraredImagingServices.com)

Infrared thermography is a process of pattern recognition. Areas of roof moisture contamination often manifest themselves as warmer areas that may be nebulous in shape and sometimes mottled in appearance, although they are commonly found in two forms; linear or puddle-like shapes. The linear shapes many times follow low areas, drainage routes, roof edges and seams. Puddle-like round or oblong shapes often form around roof penetrations such as mechanical equipment, standpipes, vents and drains.

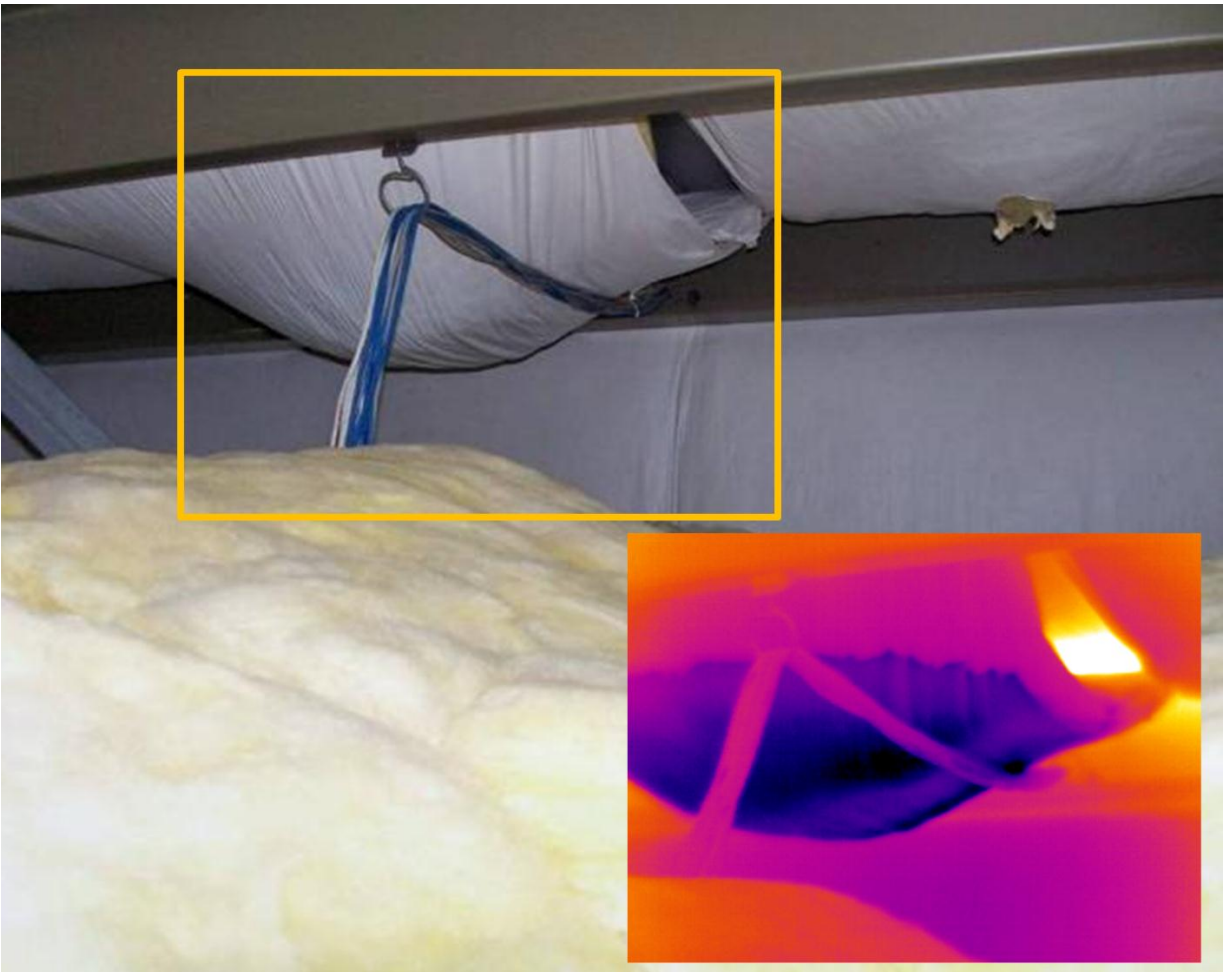
Figure 5) – Insulated metal roof visual image with thermal image inset taken from the interstitial space underneath the roof

This is the only method of thermography for vinyl-backed fiberglass insulated metal roofs because there is an air gap between the insulation and the bottom of the metal deck, so looking at the roof from above will not work. Warm or compact roofs do lend themselves to the under-roof method, although the looking-down method is usually much easier logistically, the looking-up method.

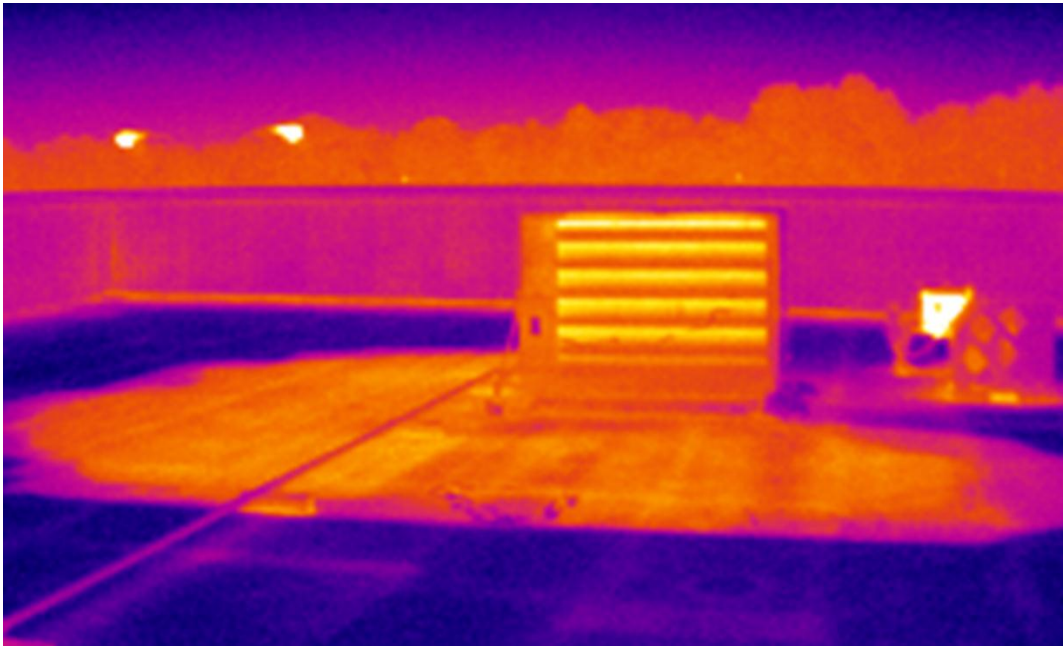
Figure 6) – Thermal image of a wet area from on top of the roof

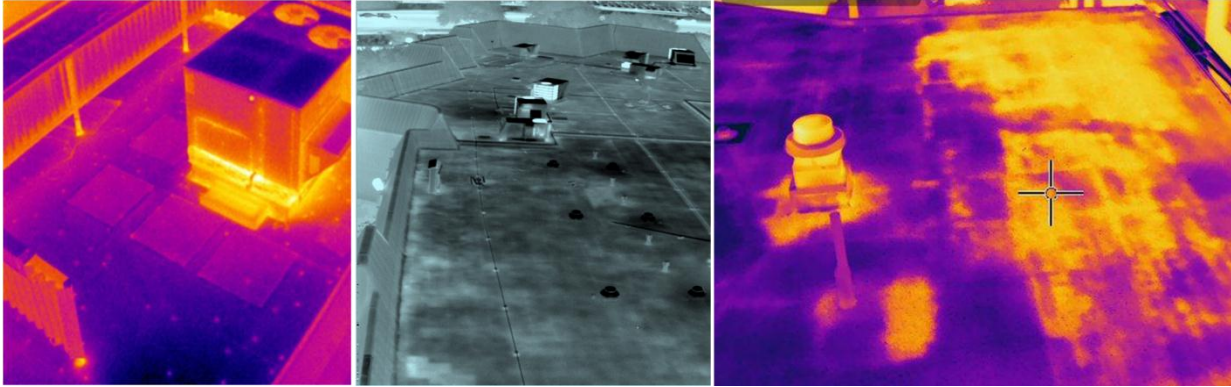
Figure 7) – Sample thermal images of roofs from an elevated vantage point

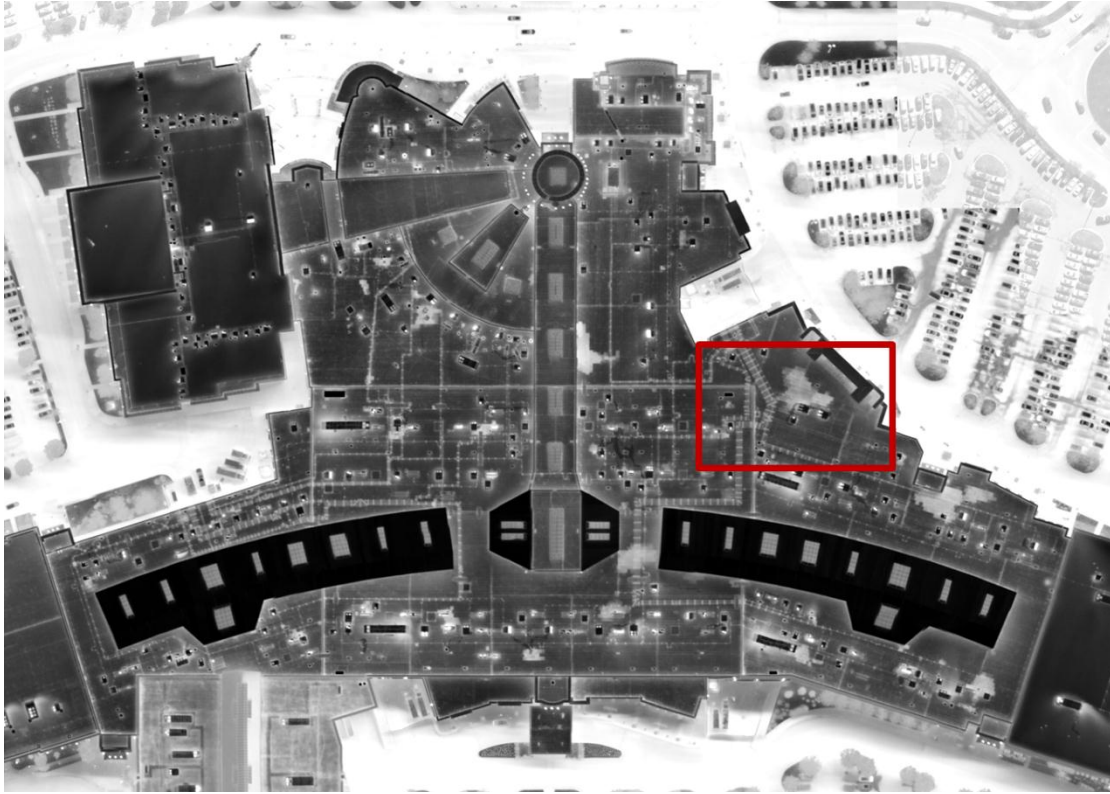
**Figure 8a) – Sample aerial thermal image of a shopping mall
(See Figure 8b for inset image)**

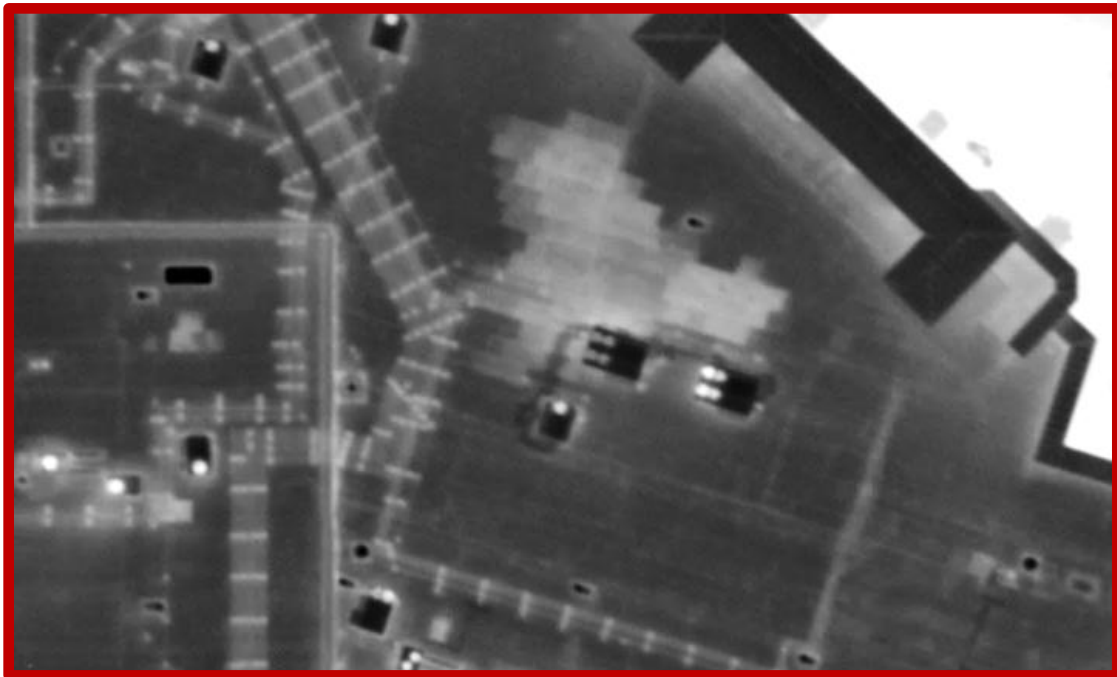
Figure 8b) – Sample aerial thermal image (inset image zoomed in)

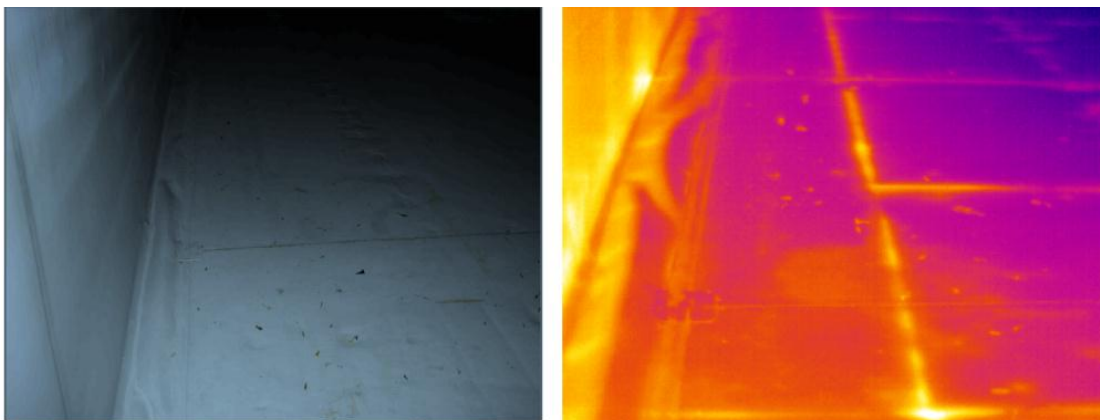
**Figure 9) – Sample on-roof visual & thermal images of an insulated roof with air leakage
(Courtesy of David Gleaton, Carolinalnfrared.com)**

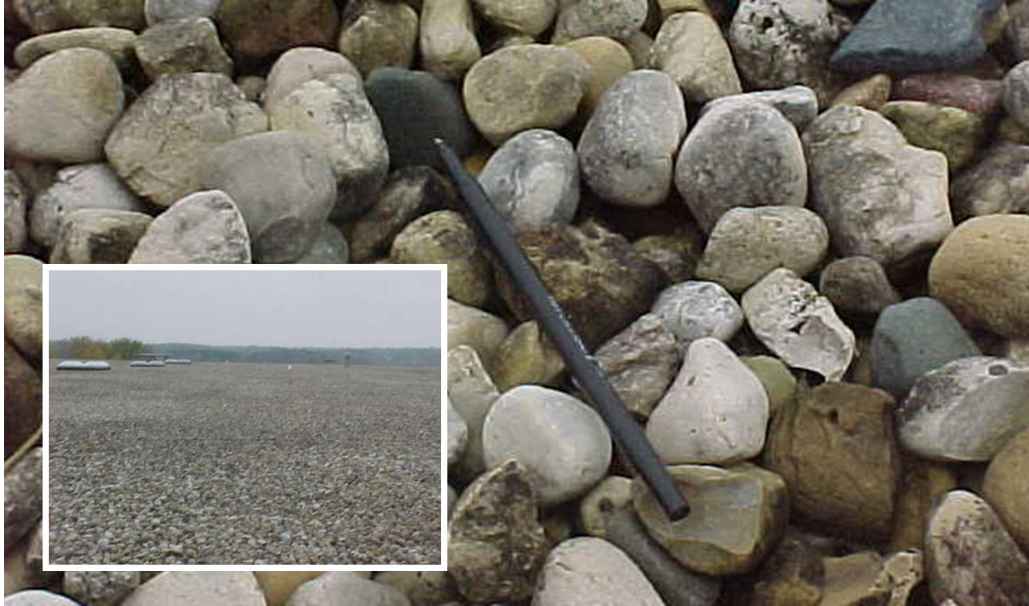
Figure 10) – Visual images of a heavily ballasted EPDM roof

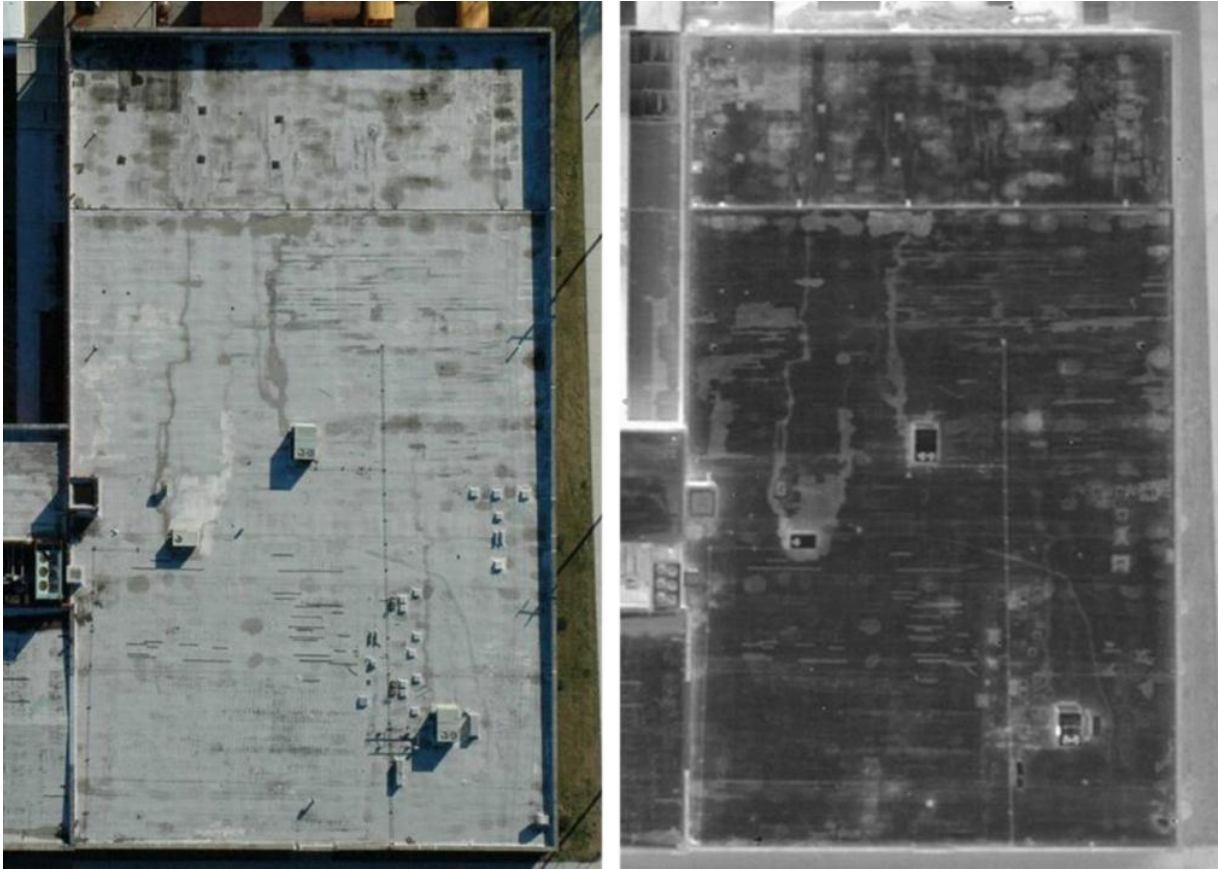
Figure 11) – Visual and thermal aerial images of a stained, worn roof with a highly reflective coating (false apparent wet areas are less reflective)

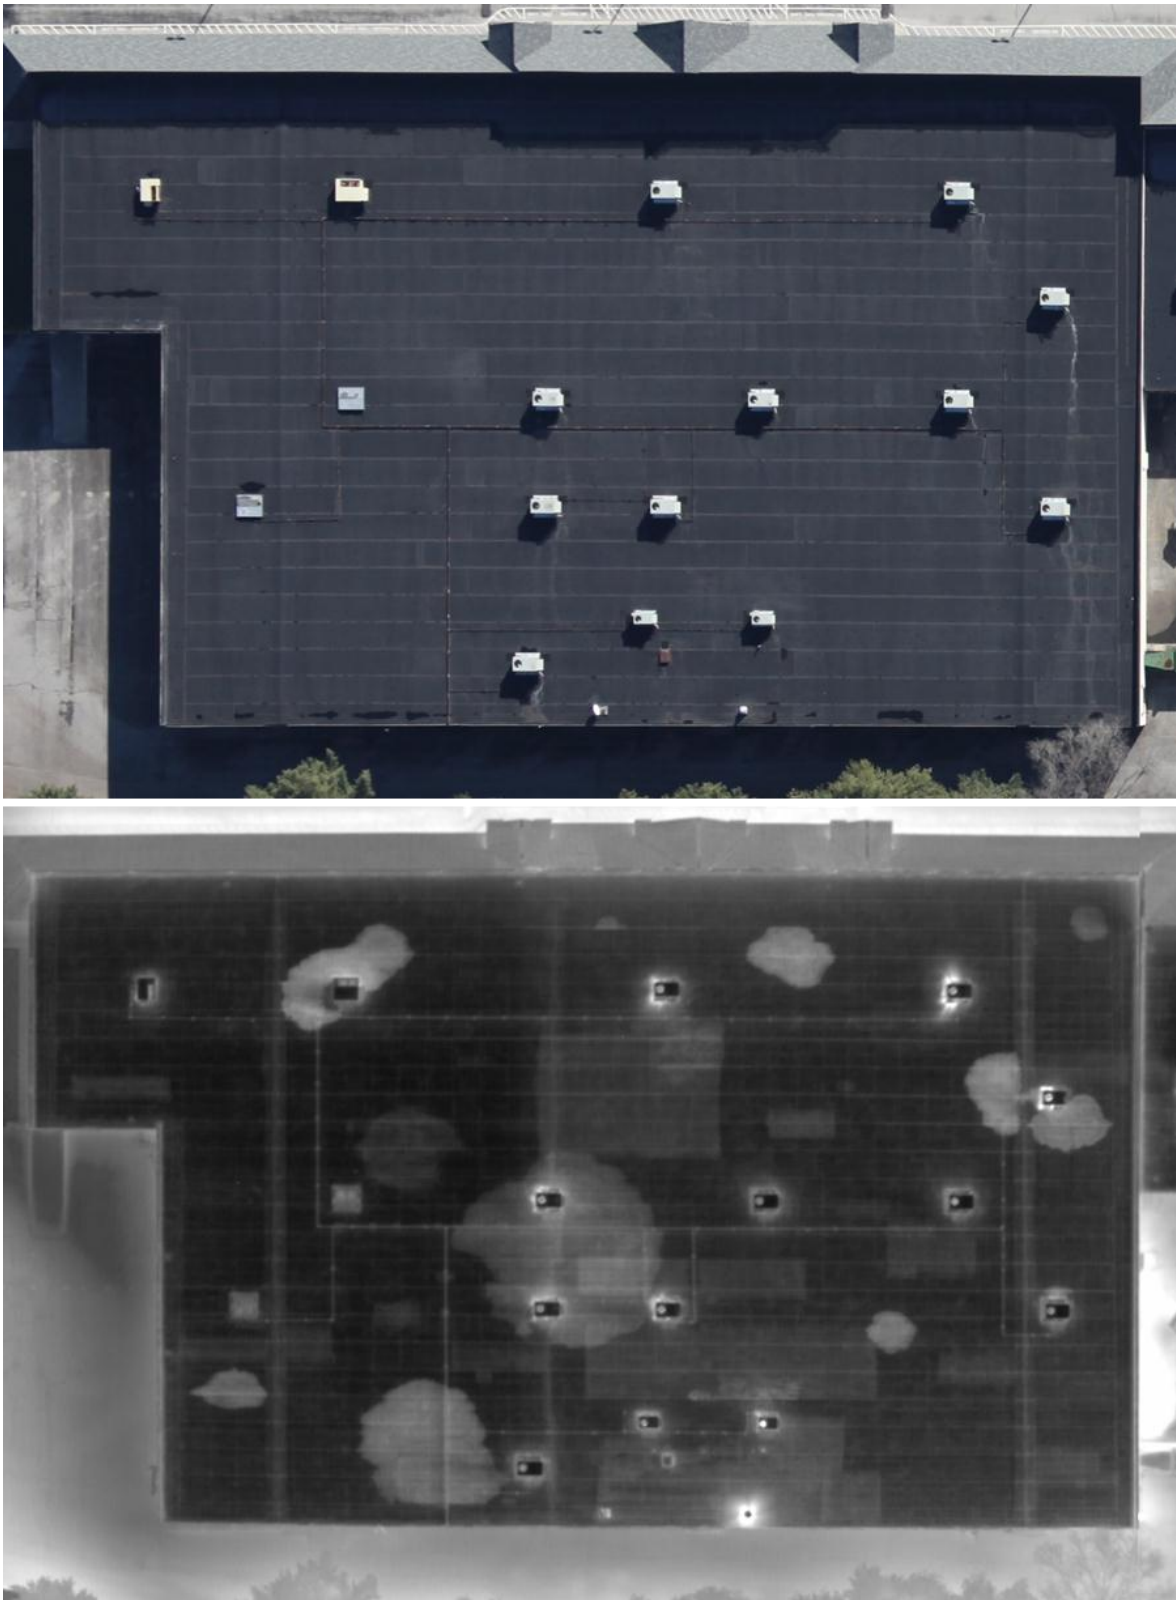
Figure 12) – Aerial visual and thermal images of a roof with patch layers and entrained moisture in different layers

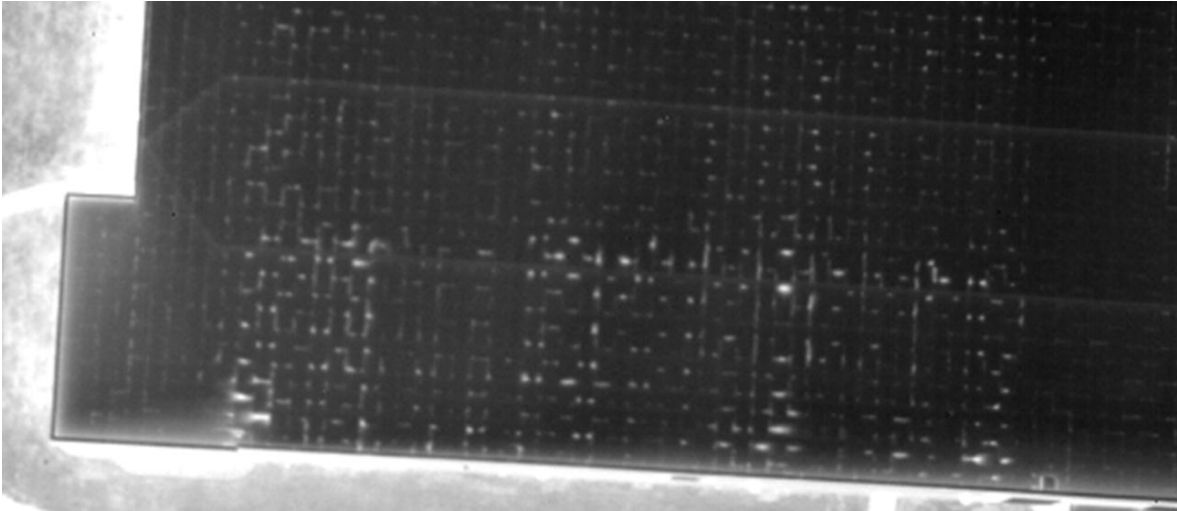
Figure 13) – Aerial thermal image of a roof with air leaks on a cold winter’s night

Since the white or reflective single-ply membrane roofs are generally better insulated, have little mass, and since they are perpendicular to the night sky, they get cold very quickly as soon as the Sun goes down and especially during the winter, depending on the dew point, condensation forms rapidly on these types of roofs. That is rudimentary, however, with even a slight excess positive pressure in a building, warm, moist building air leaks up between the board insulation and the roof membrane and condenses on the underside of the membrane, dripping condensed moisture back down onto the facer of the polyisocyanurate (isoboard). This condensation has fooled many an amateur roof thermographers into believing that the wet facer is wet insulation. It is not!
